**APPENDIX A**  
**SITE PHOTOGRAPHS**

**Marks Creek Mitigation Site Photo Points**

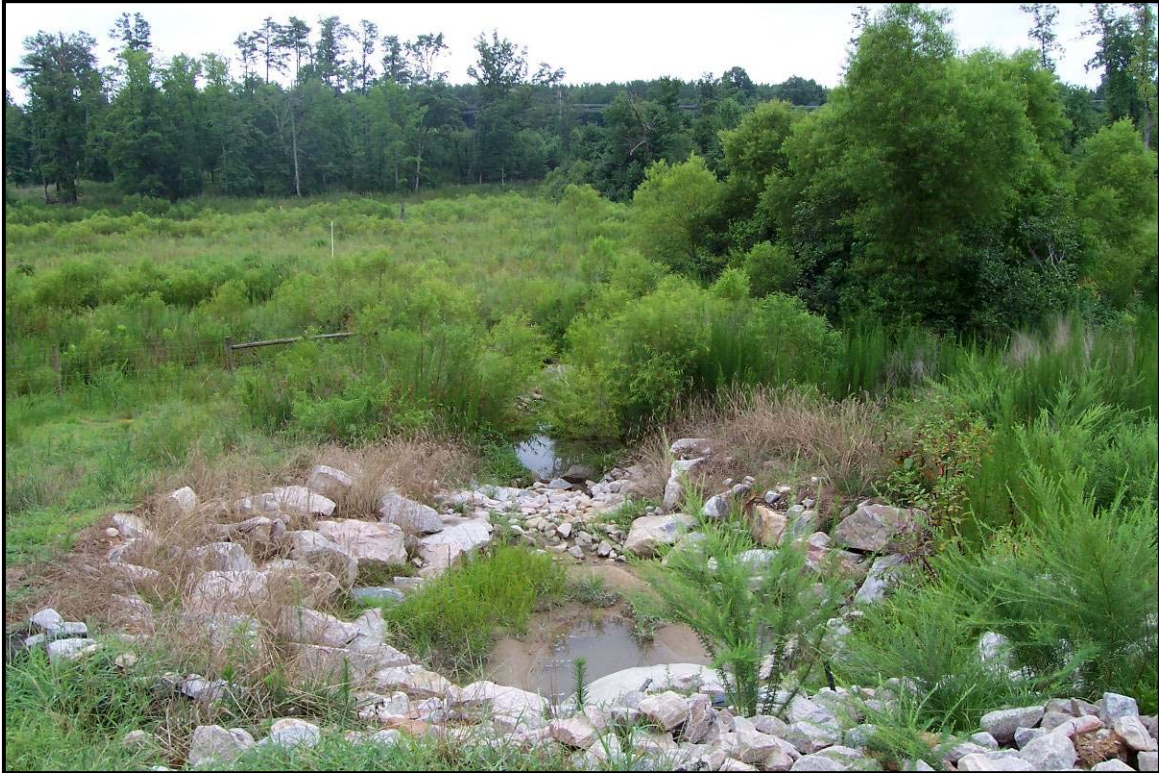
Photo Point #1. Facing south along the North Tributary - 2005

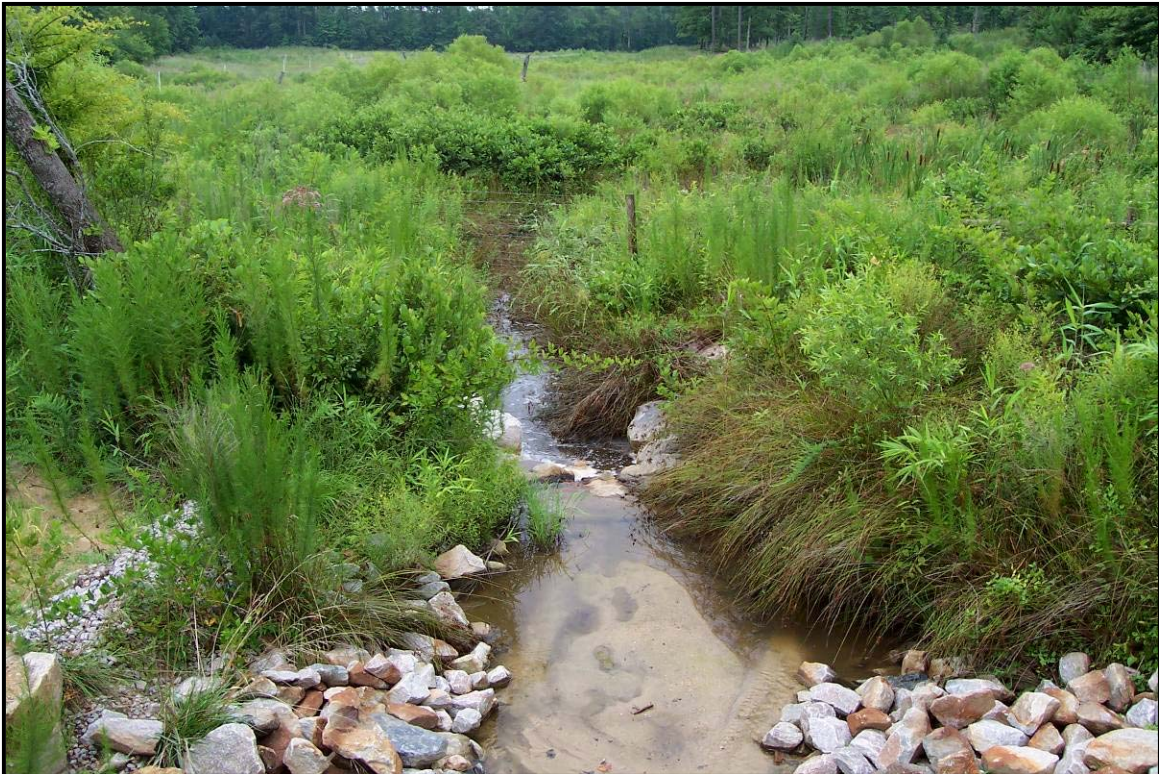
Photo Point #2. Facing east along West Tributary - 2005

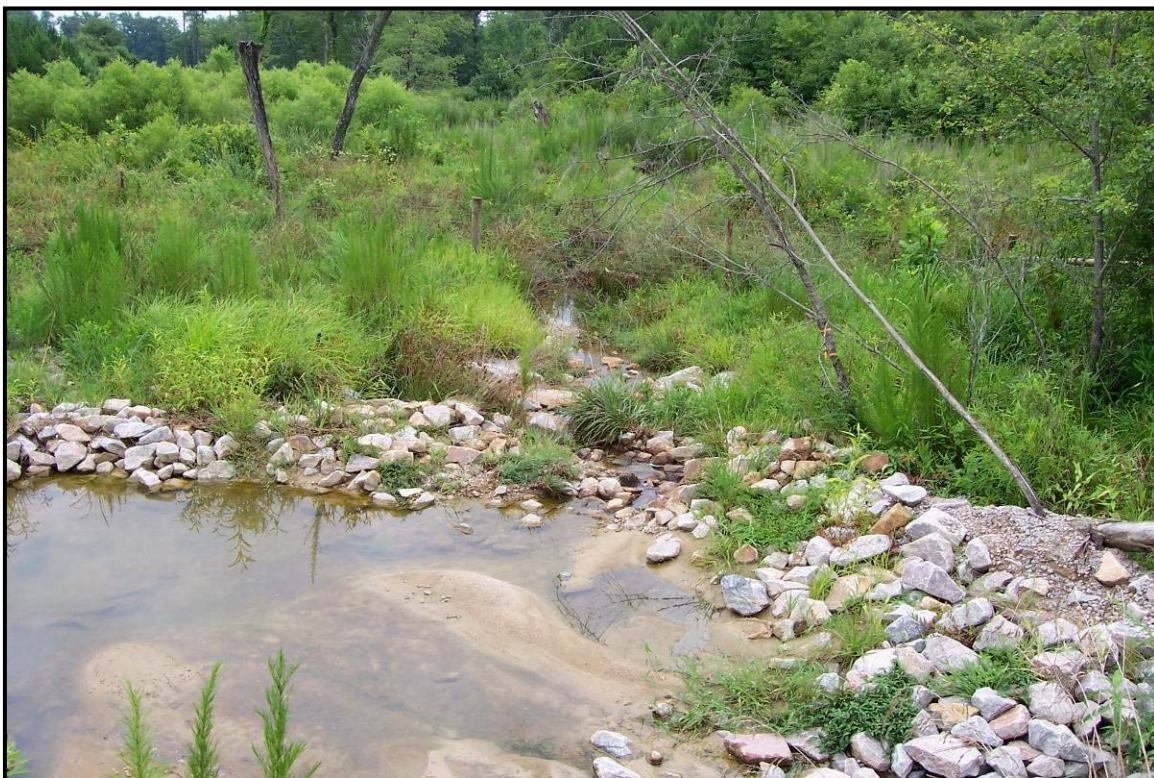
Photo Point #3. Facing east along South Tributary - 2005

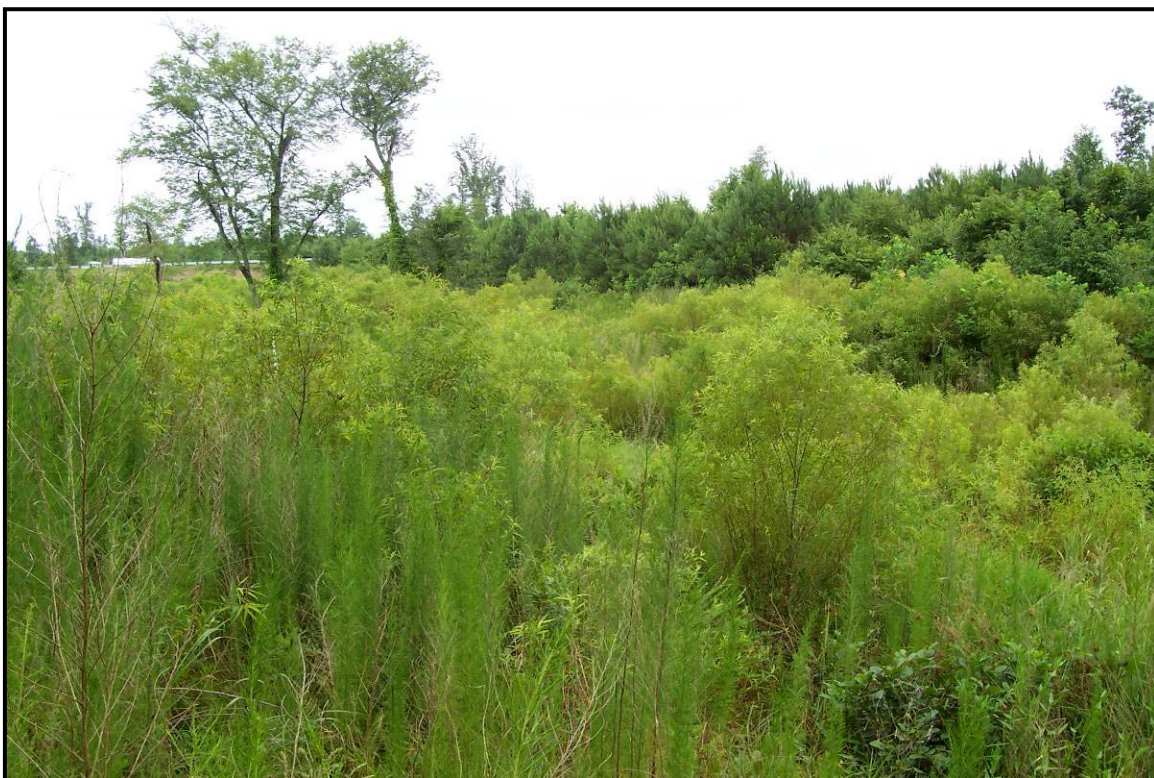
Photo Point #4. Facing west along South Tributary - 2005

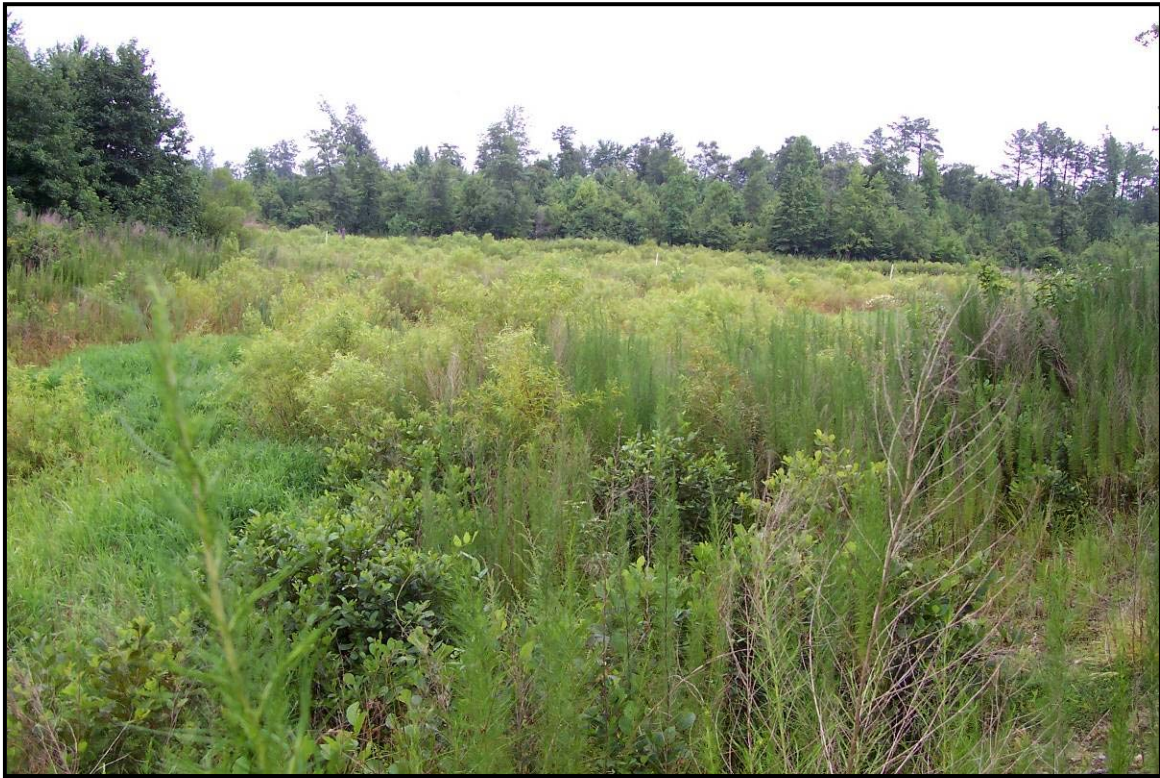
Photo Point #4. Facing northeast along South Tributary - 2005

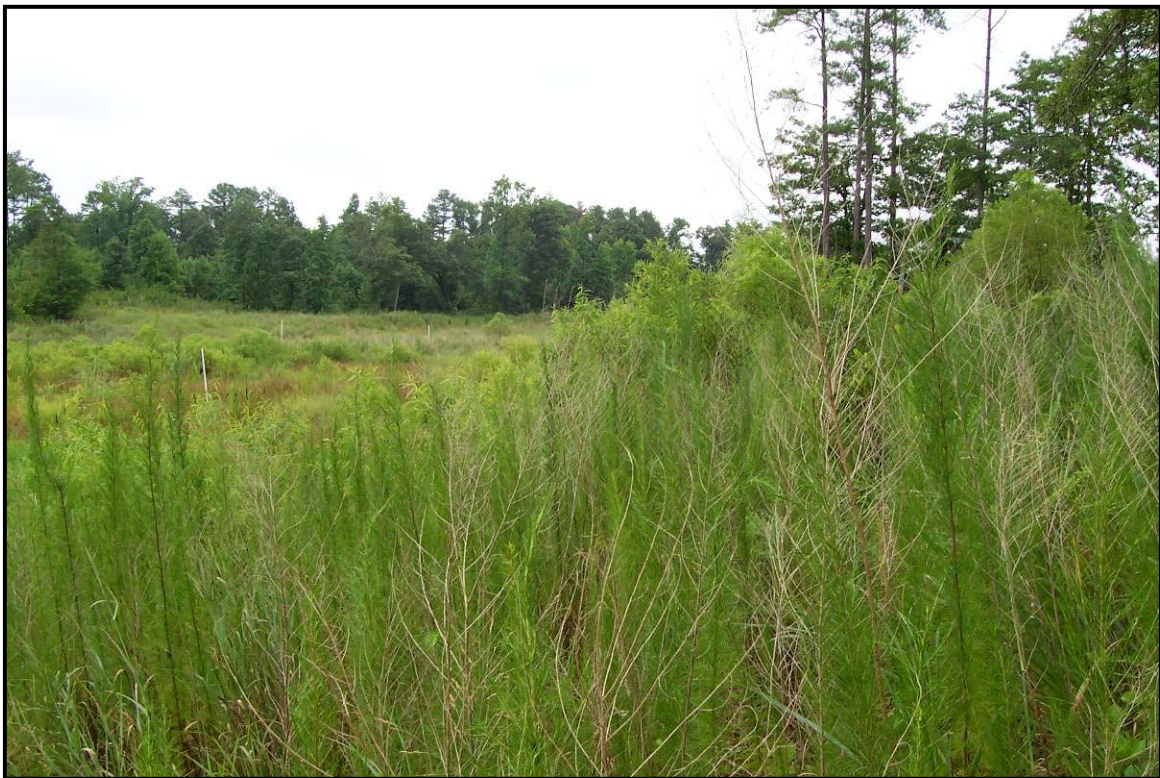
Photo Point #5. Facing north across South, West and North Tributaries - 2005

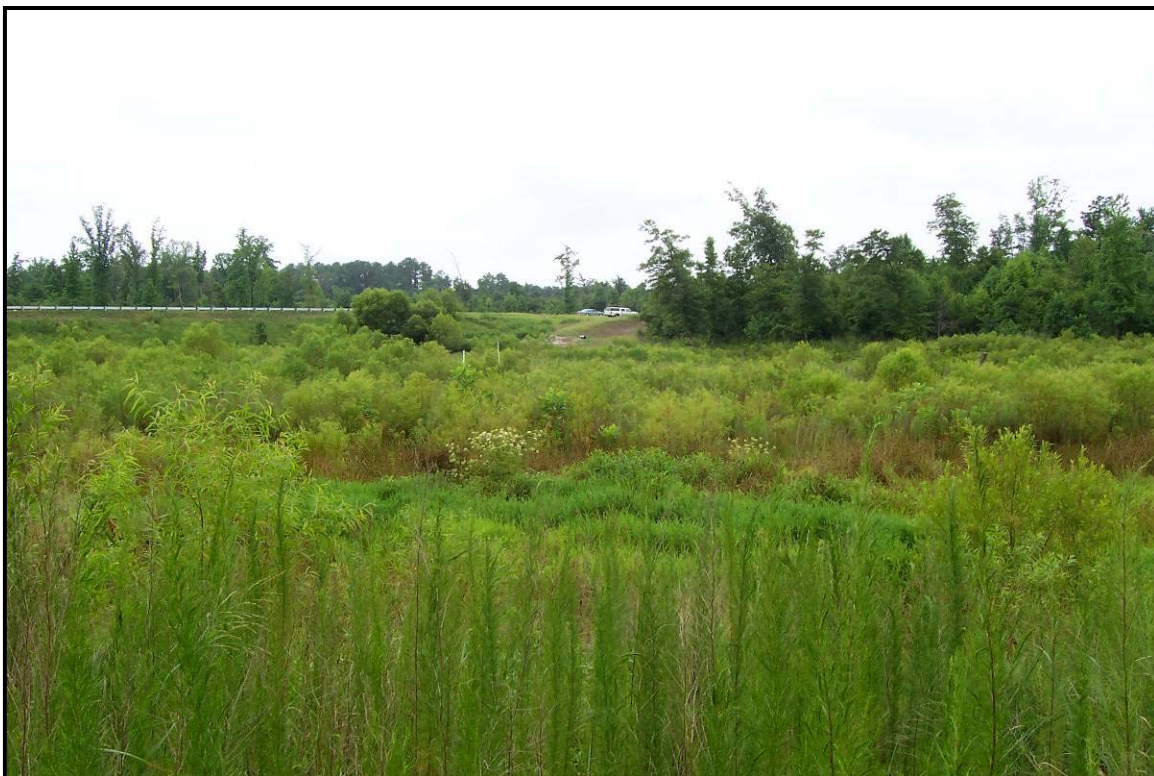
Photo Point #5. Facing northwest across South and West Tributaries - 2005

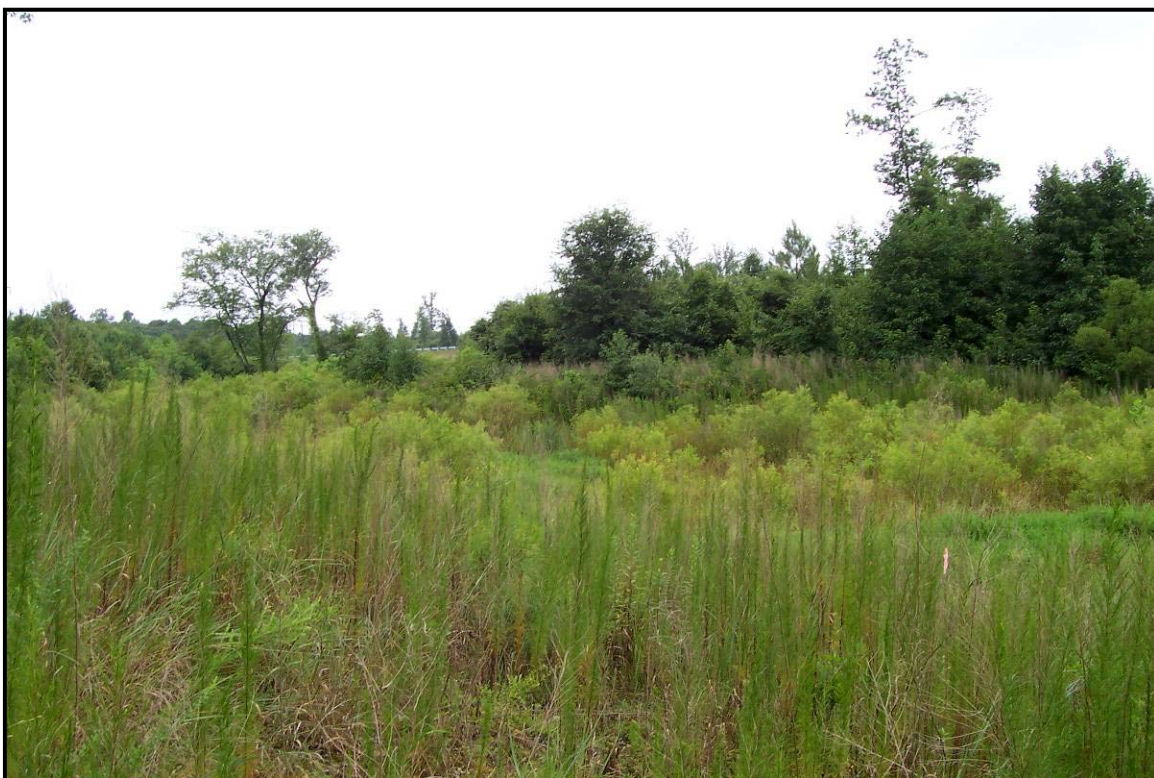
Photo Point #5. Facing southwest along South Tributary - 2005

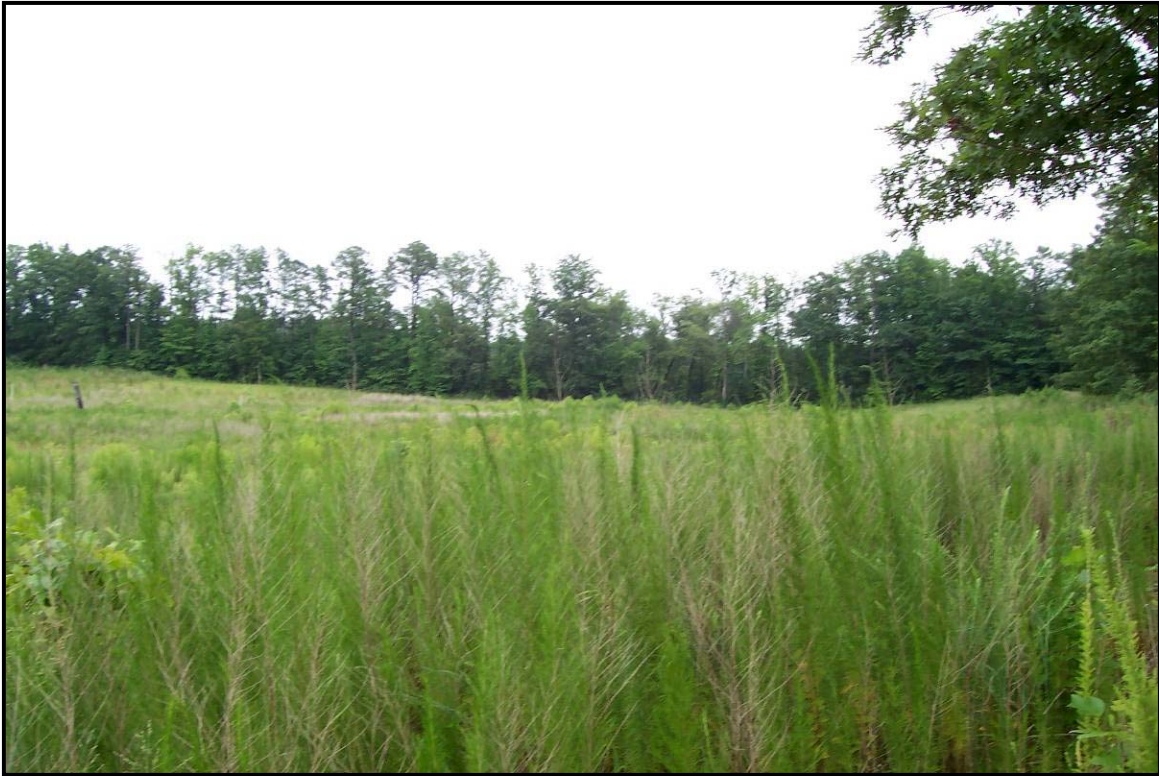
Photo Point #6. Facing east along Main Channel – 2005

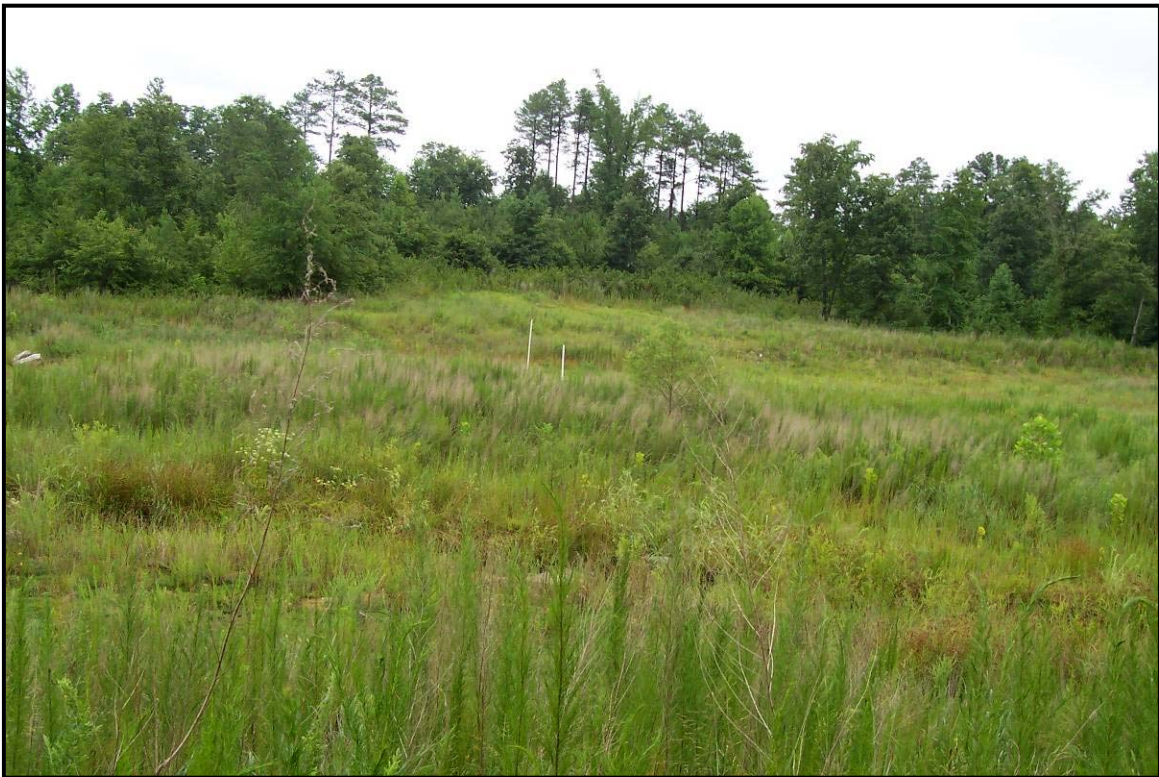
Photo Point #6. Facing north across confluence of Main Channel and North Tributary - 2005

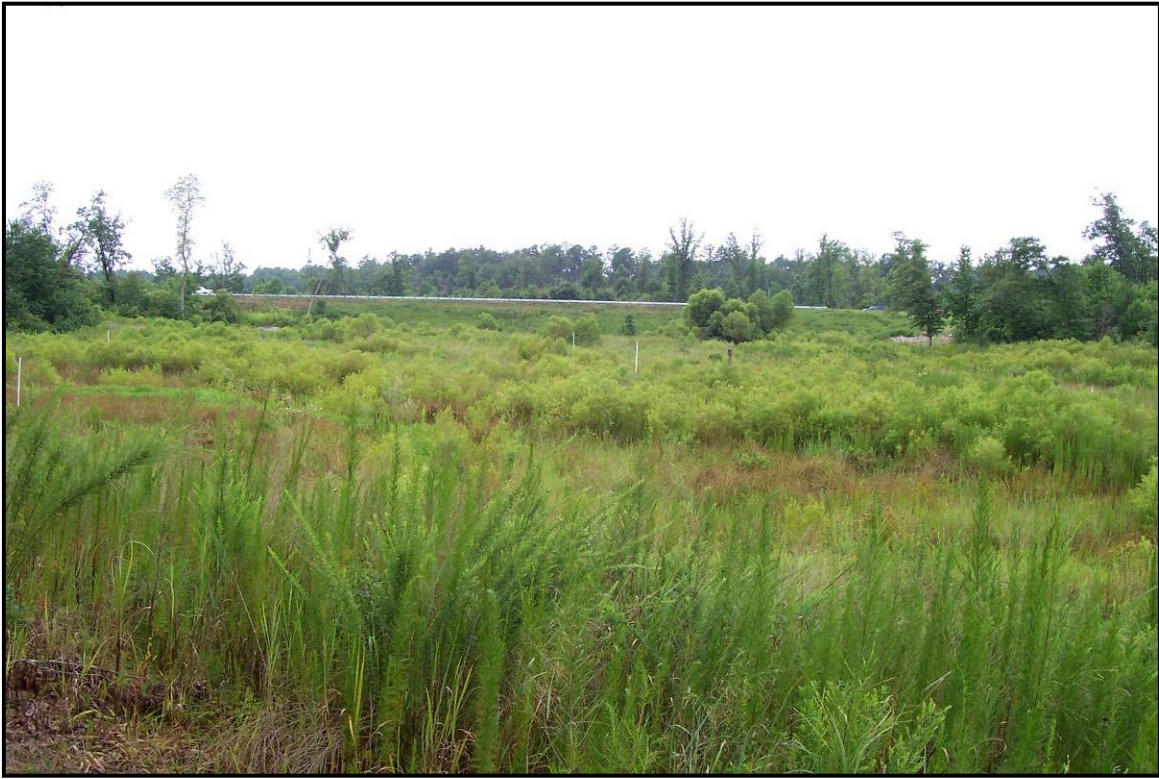
Photo Point #6. Facing west at confluence of West and South Tributaries - 2005

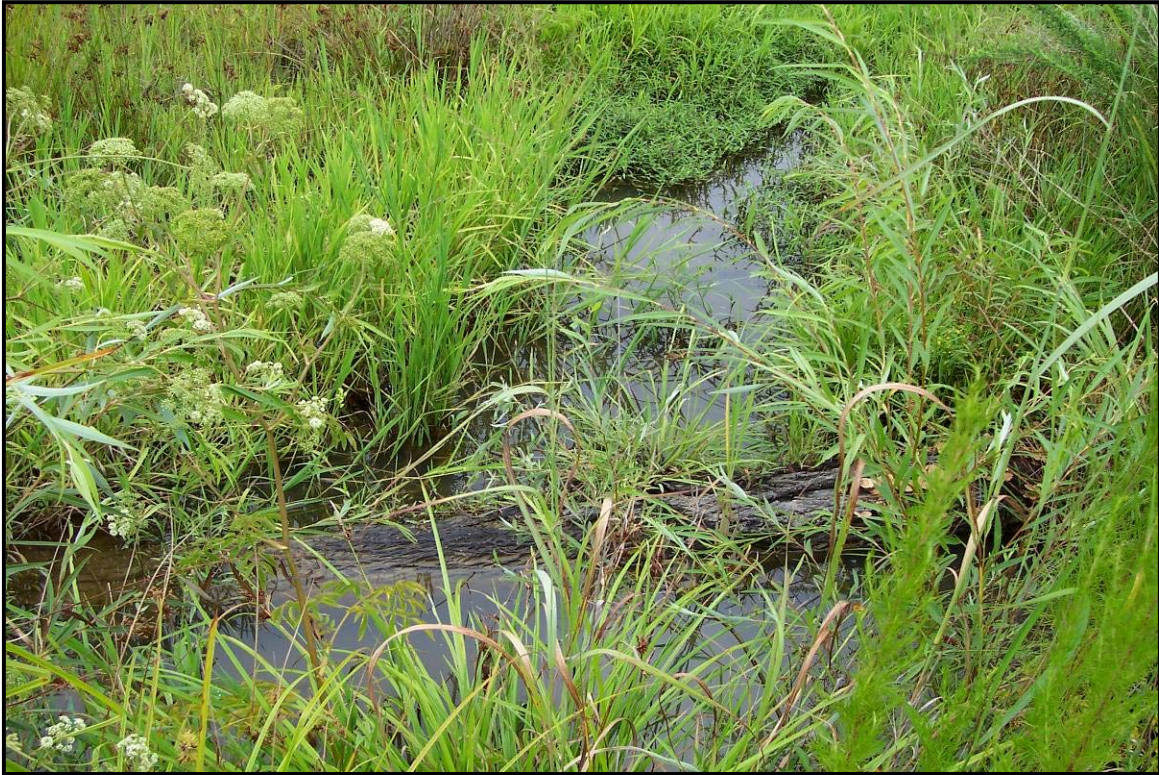
Undercut log vane at Station 13+63 along the North Tributary – 2005

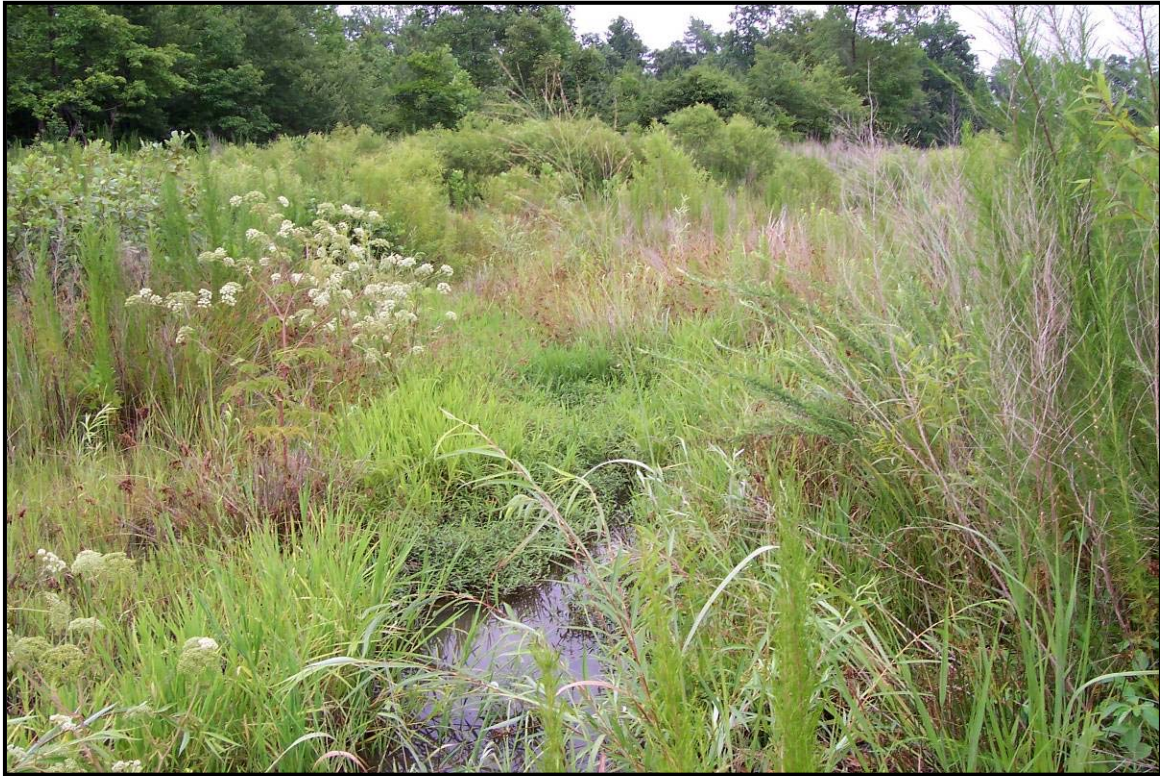
Vegetation within the bankfull channel between Stations 12+34 and 16+15 along the North Tributary – 2005.

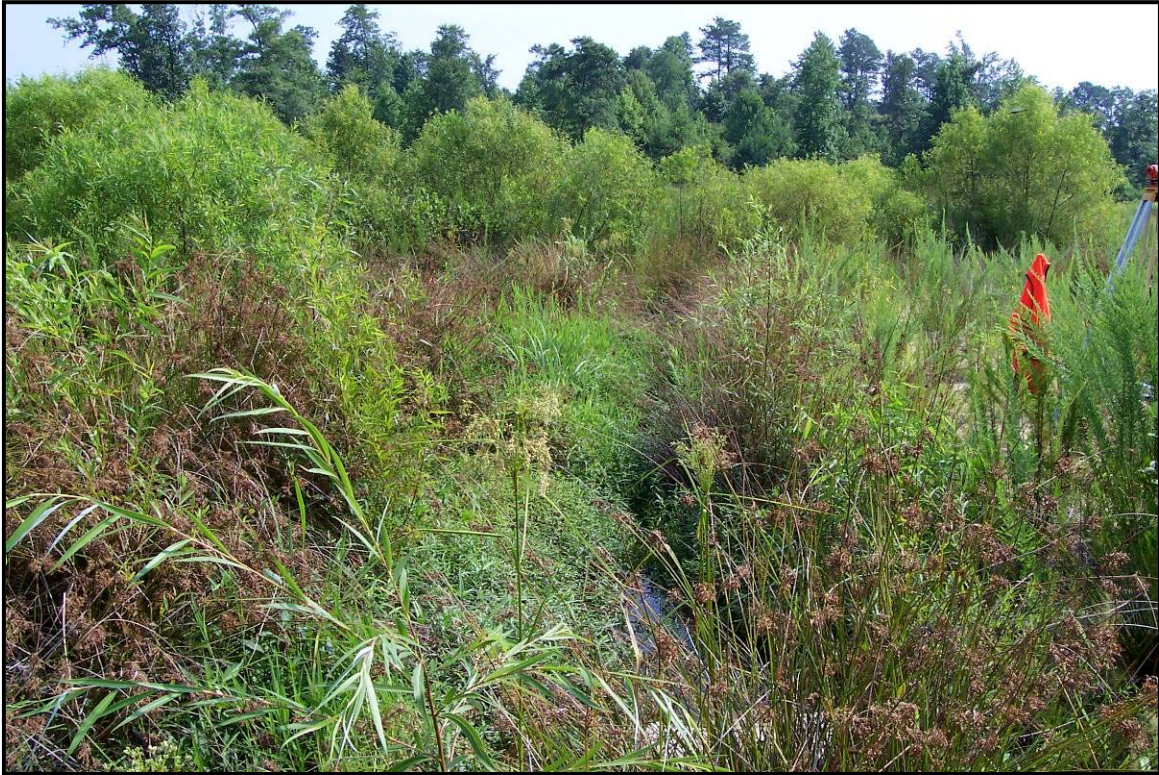
Vegetation within the bankfull channel between Stations 11+07 and 12+70 along the West Tributary – 2005

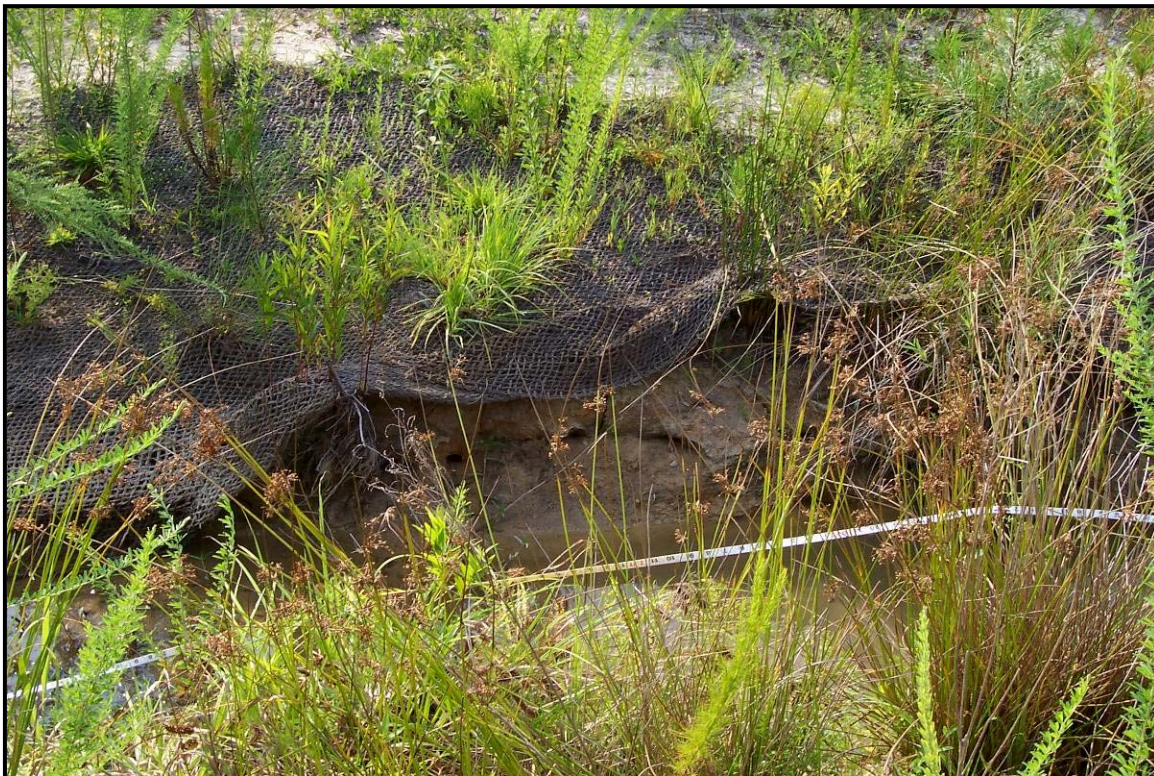
Localized bank erosion at Station 13+00 along the West Tributary – 2005

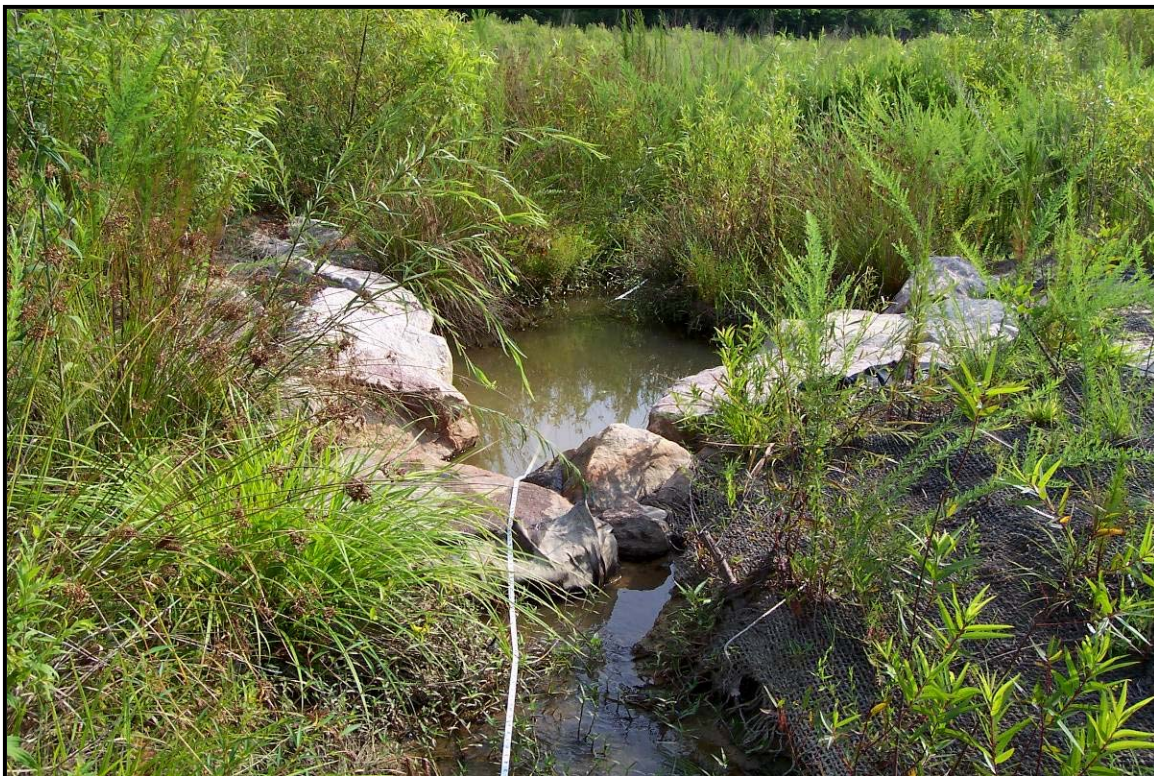
Undercut cross vane at Station 13+18 along the West Tributary – 2005

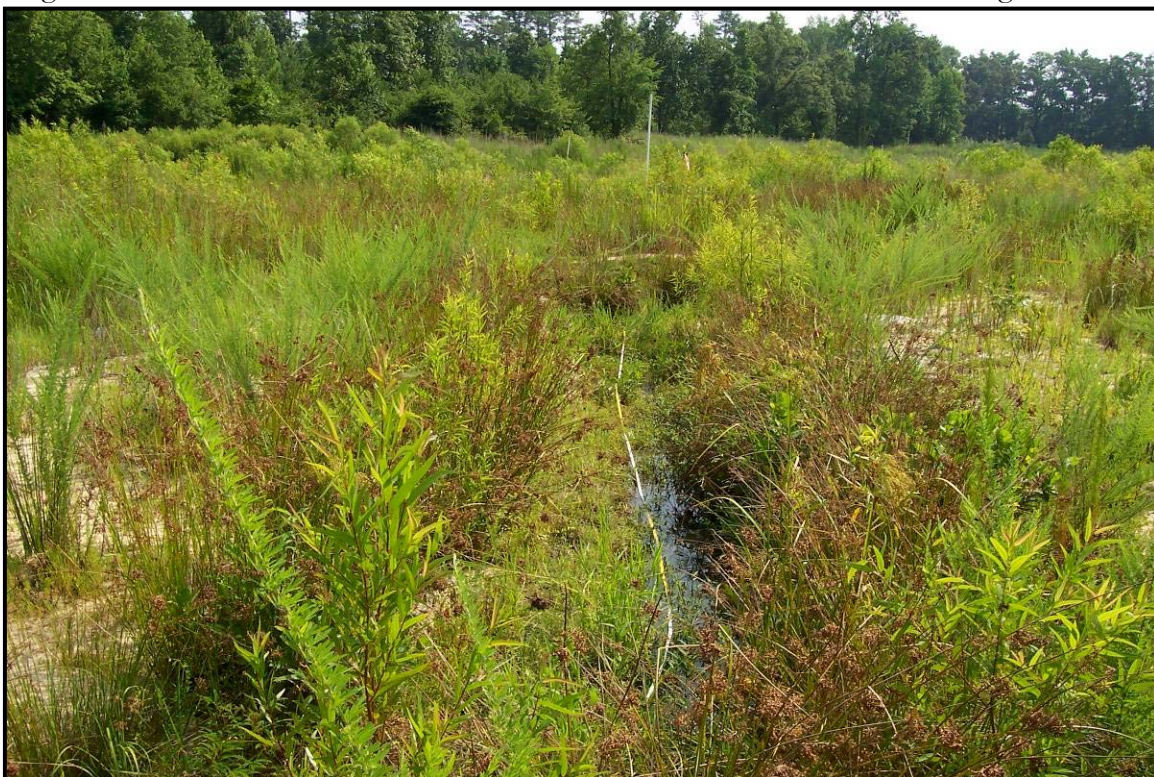
Vegetation within the bankfull channel between Stations 13+35 and 15+55 along the West

Tributary - 2005

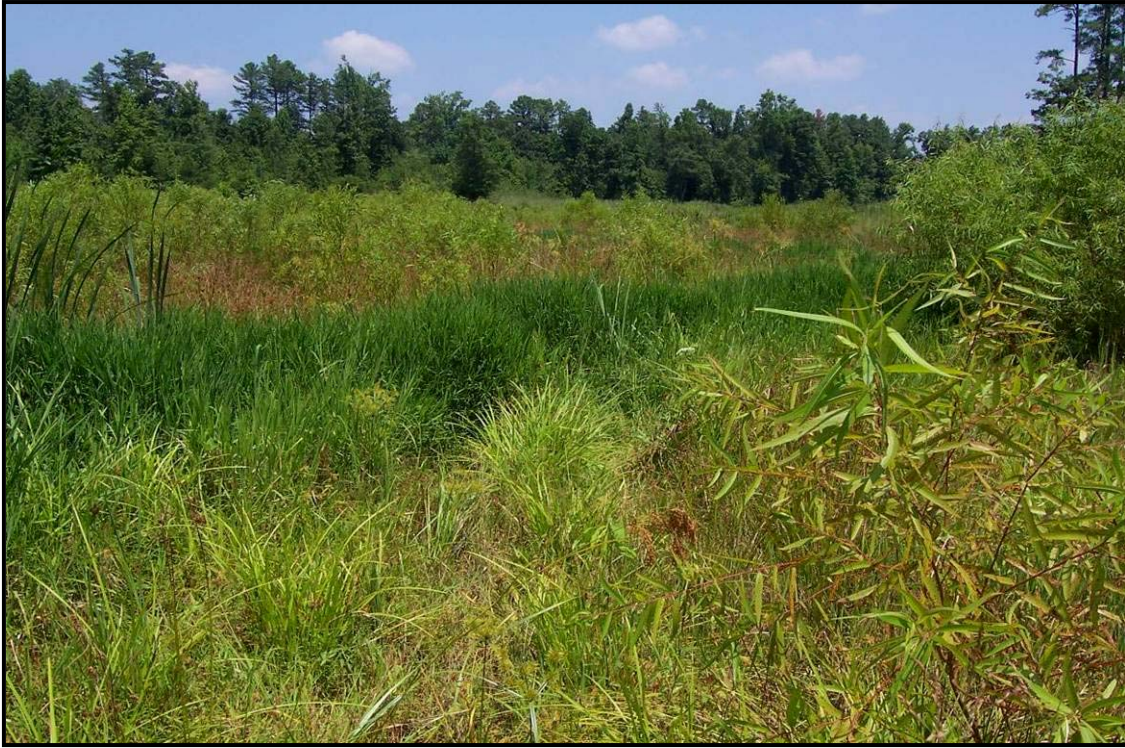
Vegetation within the bankfull channel between Stations 15+00 and the end of the reach associated with the South Tributary – 2005

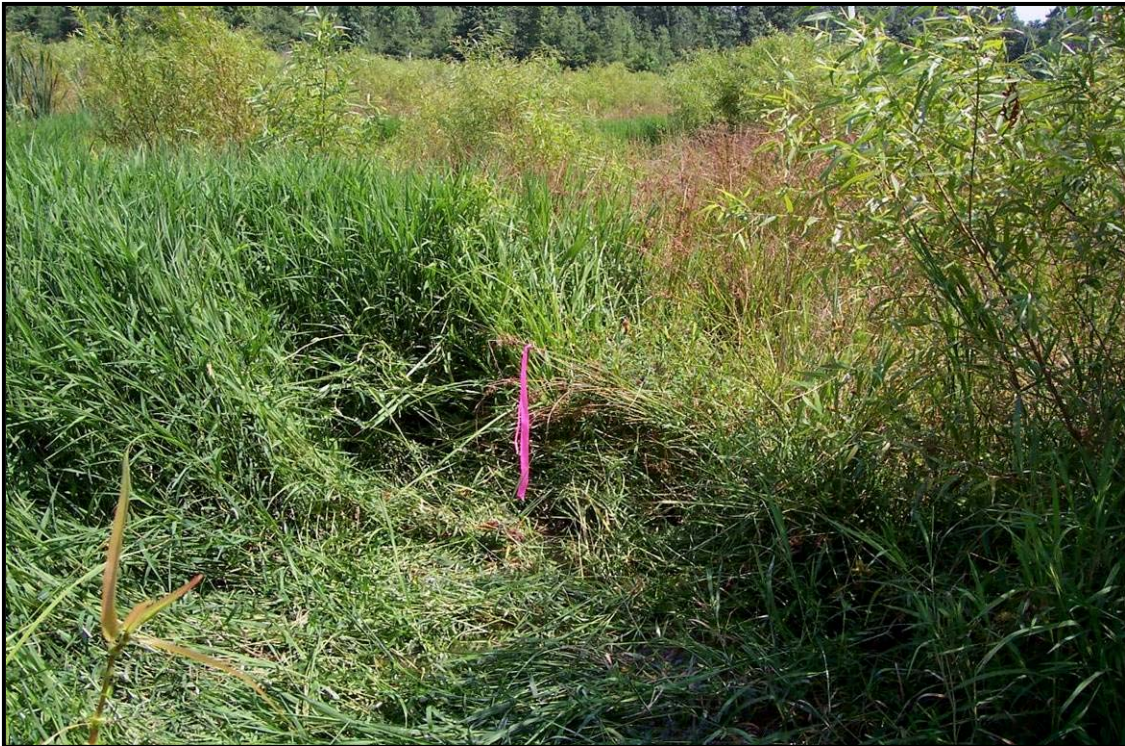
Vegetation within the bankfull channel at Station 16+00 along the South Tributary - 2005

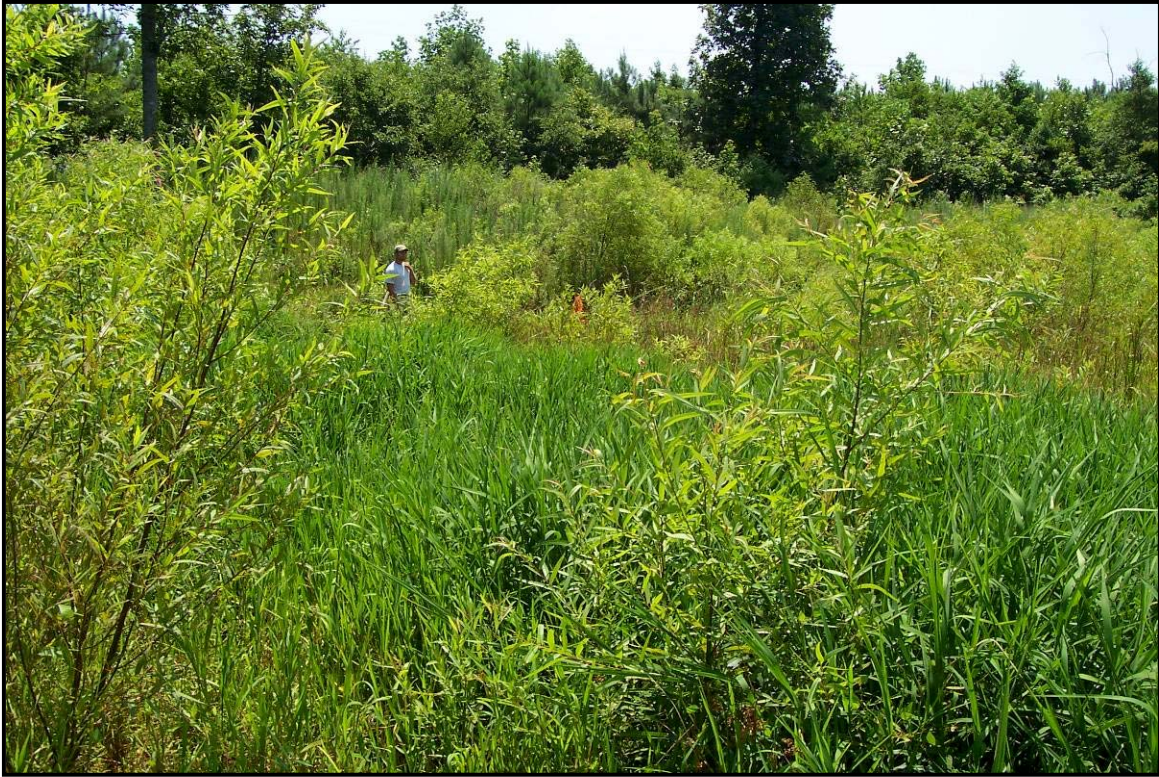
Vegetation within the bankfull channel near Station 10+00 along the Southwest Tributary - 2005
